**North Slope of Alaska ARM Facilities
Monthly Status Update
Sandia National Labs**

January 2018

INFORMAL AMF3 INSTRUMENT STATUS REPORT FOR January 19 - January 26, 2018

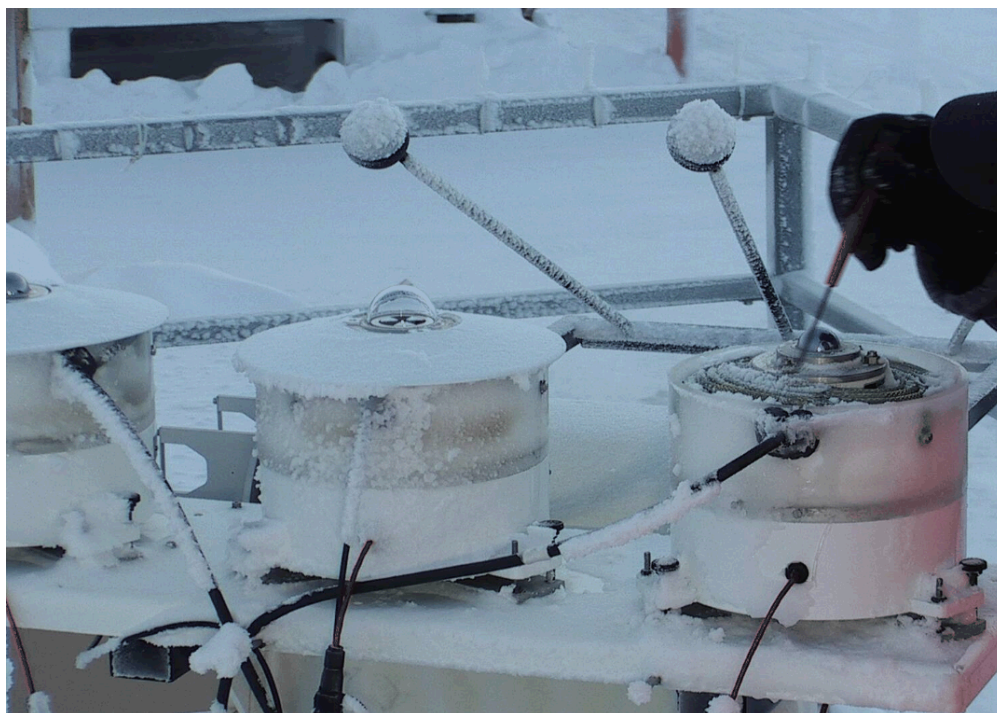
Radiometer ventilators are having issues of filling with snow due to mentor changing fans across all ARM facilities to all be the same.

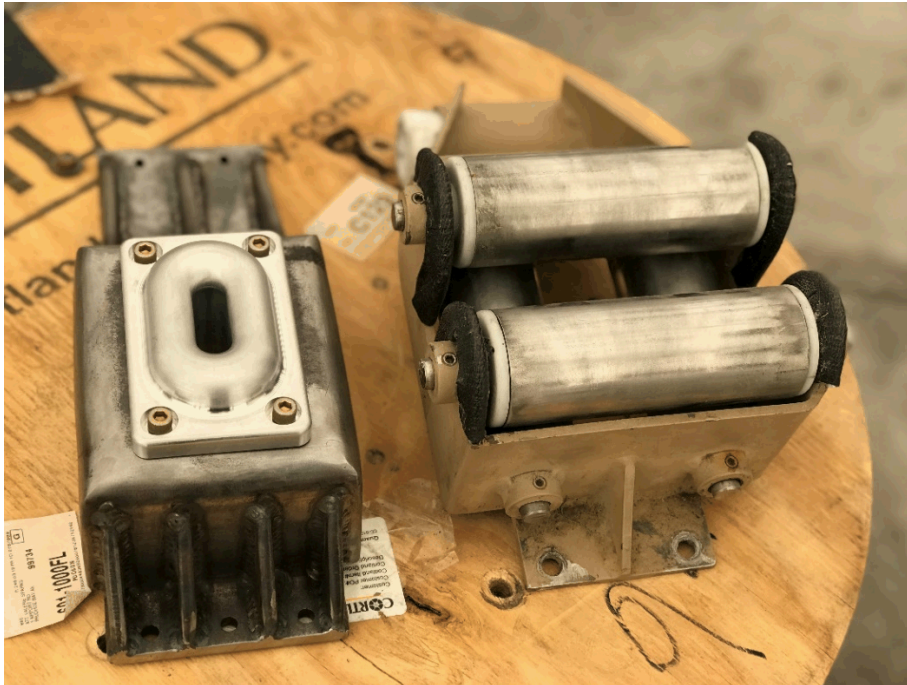
Figure 1: Old levelwind guide (right) vs new levelwind guide (left). New pawl is stronger and eliminates sharp edges that can damage the tether.

For the month of January, the TBS crew continued to make progress on the TBS winch rebuild. The winch from the winch trailer in New Mexico was removed and upgraded to match the newly upgraded Oliktok winch. Both winches received new bearings, maintenance to the pawl shaft and housing, a new linear bearing and shaft were installed, and the winch drums were re-centered. The Oliktok winch trailer was also outfitted with additional cross members at the winch's mounting location for additional support. The Oliktok winch has been mounted to the TBS trailer and the wiring has been configured. A test fit with both the helikite and aerostat balloons were performed to check clearances with the reorganized trailer. It was found that there is interference between the balloon support arms and the generator. In addition, the support arms are too long which would create interference with the tether at extreme tether angles. Ideas have been generated to solve this issue and it will be addressed in February.

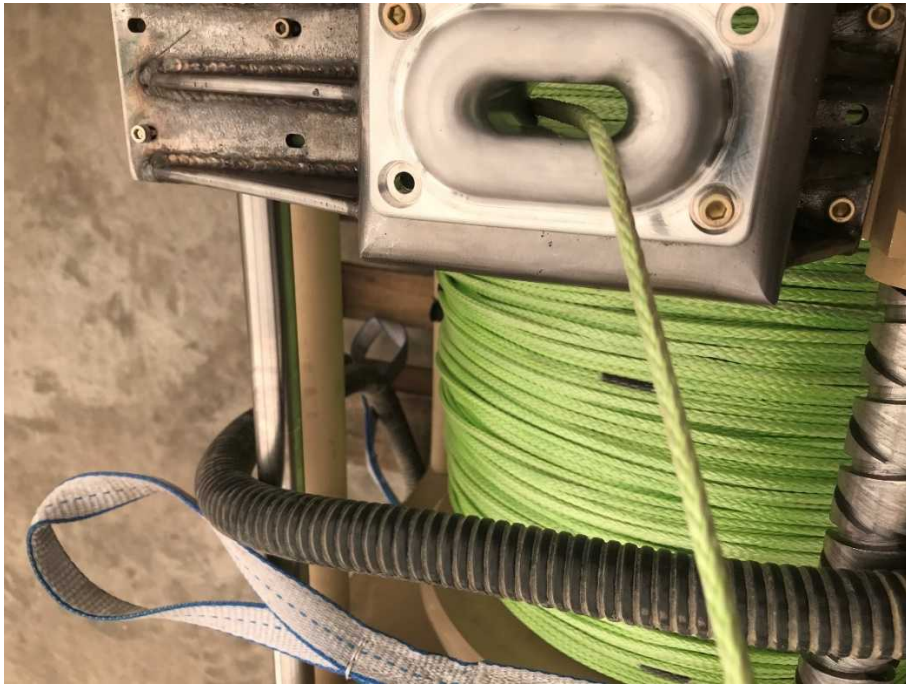
Figure 2: Tether in new levelwind guide

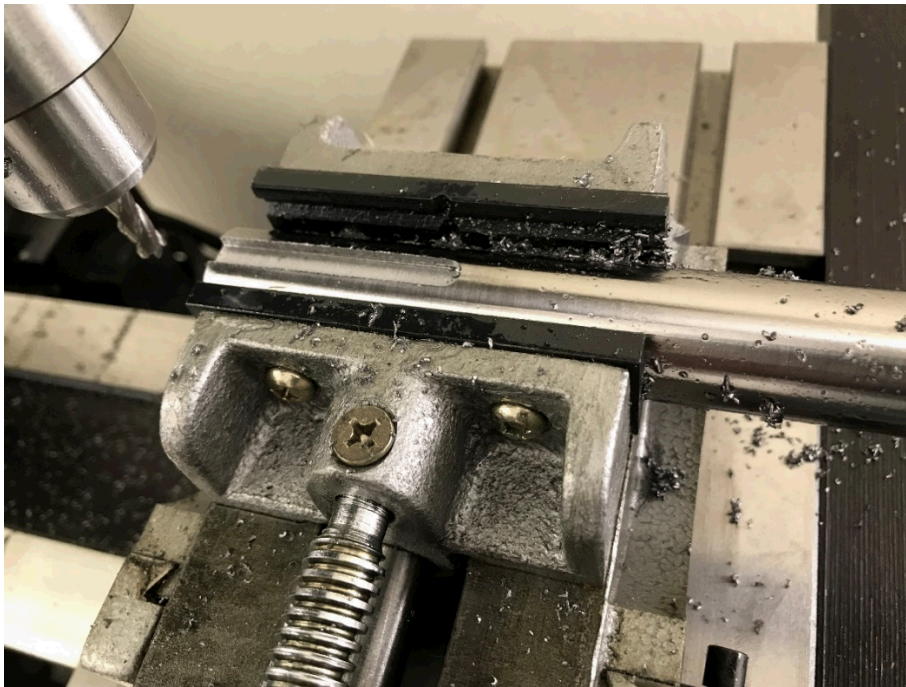
Figure 3: Machining of linear bearing shaft to add key slot for new sprockets

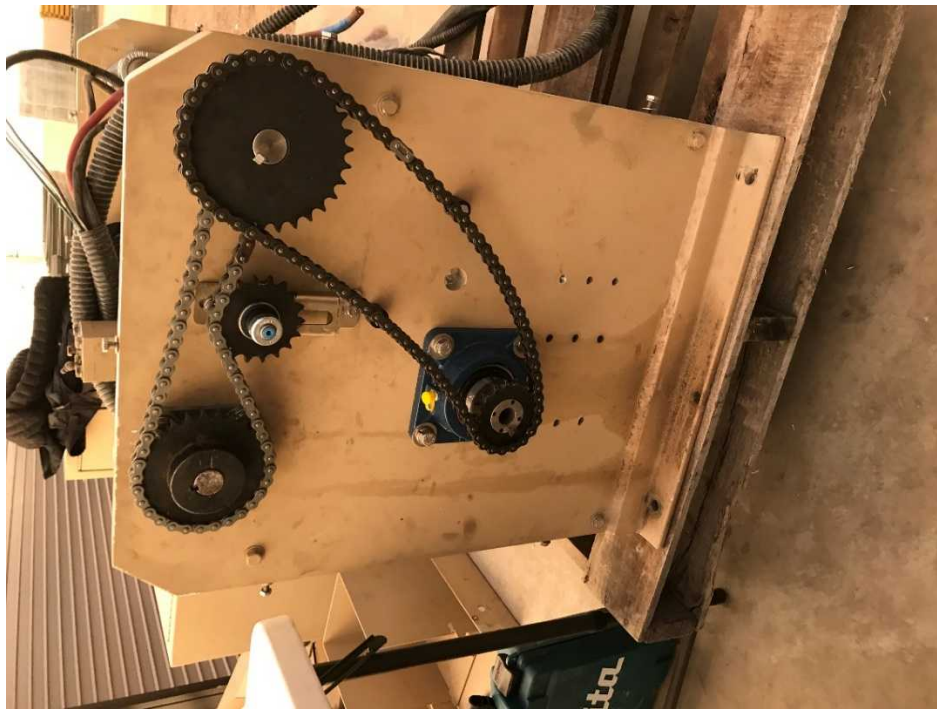
Figure 4: New gear reduction system to help better match the levelwind speed to the drum speed.
